Hillside Golf Course Sidney, Nebraska Irrigation System Assessment 100% Submittal

Irrigation System Evaluation

This evaluation was conducted to review the existing irrigation system at the 18 hole Hillside Golf Course. Brian Keighin, Principal from Irrigation Technologies was on site October 12-13,2011 to examine the current irrigation system, and operational practices.

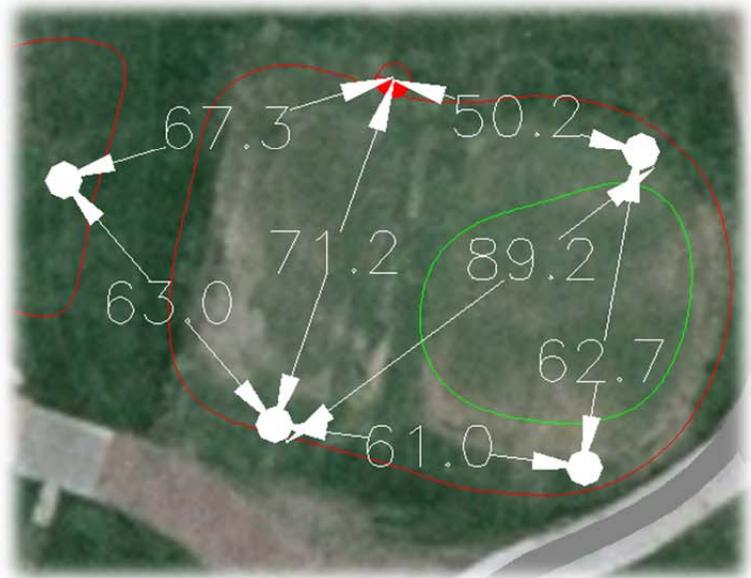
Illustration.2 Head spacing at PG by 10 Tees complex

The same holds true performance wise, for heads that are spaced too closely together. As shown in illustration 2, some of these heads are spaced 50.2'. Heads designed to throw 75' spaced this close together will always leave a wet area.

As the system has aged, and sprinkler heads have begun to fail, new heads have been installed. The original 670 heads are no longer manufactured by Toro, and repair parts are limited. The old heads are being replaced by Toro 850 series heads. The new 850 series heads are a good direction to go and will allow the system to perform at an improved performance level. The new heads will perform at a slightly higher performance level than the original equipment simply due to the improved distribution uniformity (DU) of the nozzle. However, it is important to consider the orientation of the new heads. Heads perform best when set level, and at grade. This allows the nozzle stream to distribute water in a uniform manner, and achieve a high DU. A level sprinkler will minimize any stream blockage from ground interference. An inventory needs to be taken to identify heads that are in poor, failing condition and should be replaced as capital dollars allow. It is cost prohibitive to properly adjust the spacing of the installed equipment unless the entire area and/or hole is changed. Varied spacing can only be corrected by installing new heads at the proper spacing. This requires a new irrigation system.

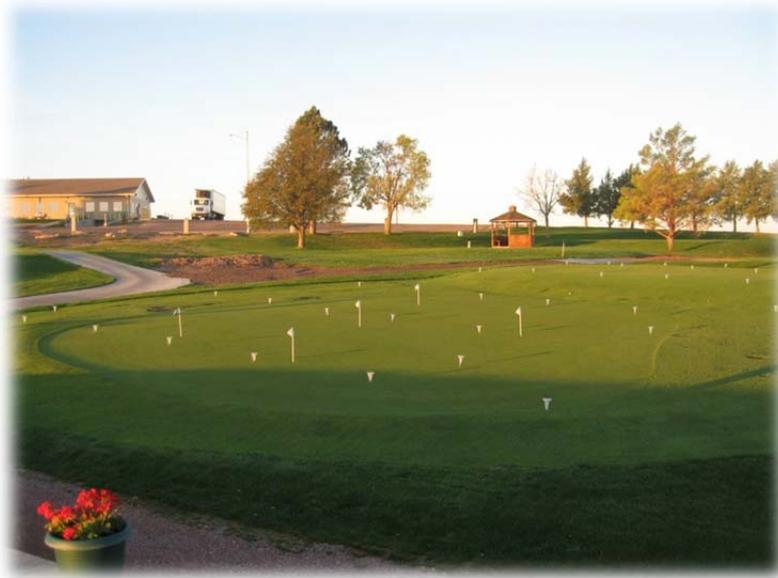
Picture 1. Catch Can Testing on PG by 10 tees

During the overnight irrigation cycle on October 12, 2011 catch cans were placed on the putting green near 10 tees. The purpose was to identify the DU of the existing heads. The irrigation system was set to operate a regular cycle. Forty-one (41) catch cans were placed on the green surface. The collected volume of water was recorded into an irrigation schedule worksheet along with the soil type, average root depth, and plant species. The collected volume identified an application rate of 0.71" per hour and a DU of 41%. The 41% DU rates well into the poor category. The poor category is identified by a DU of less than 55%. New equipment at a tighter uniform spacing, pressure, and flow can yield a field test DU of 80-85%. There is an exceptional opportunity for sprinkler performance improvement at Hillside Golf Course.

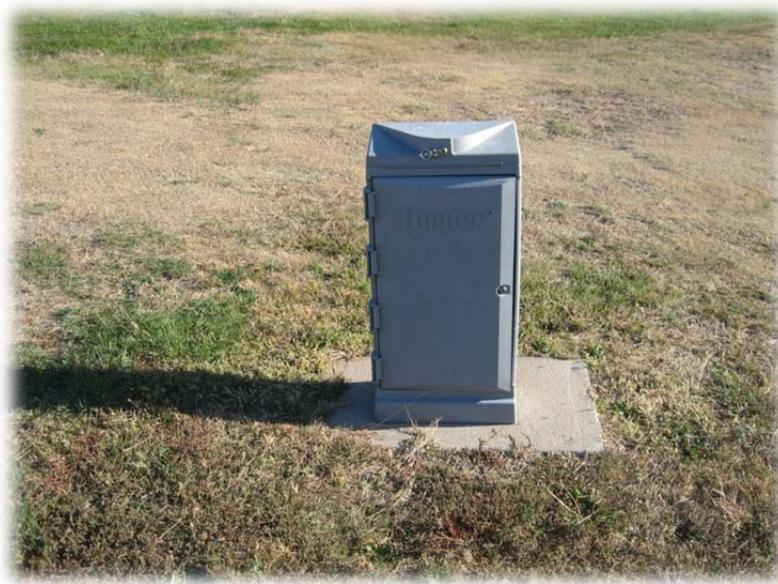
Picture 2. Hunter Irrigation Satellite

The irrigation system is controlled by a group of field controllers, commonly referred to as satellites. The Hunter brand irrigation satellites are the gray colored pedestals located throughout the course. This satellite, (picture 1) is several generations behind the current Hunter offering. Each satellite controls a group of heads within relative close proximity to the satellite. Each satellite operates independently of one another at Hillside. It is very common on most golf course irrigation systems for each satellite to communicate via radio or hardwire to a central computer. The central computer coordinates the irrigation cycle, allows the superintendent the ability to apply a specific amount of water to a specific area, and maximizes the efficiency of the pump station thereby reducing power consumption and utility cost. Based on the information collected during the site visit and the observed 12 hour irrigation cycle, a central control system has the potential to reduce the water window by a minimum of 2-3 hours, a 20-25% reduction. The city will realize a similar reduction in the kWh used at the pump station to power the pumps. Hillside golf course should consider installing a new control system that includes central control capability. An budget cost for a new central control system is \$125-150K. A new control system can be designed as phase one of a new irrigation system, and will return immediate and noticeable results in terms of turf quality and operational costs.

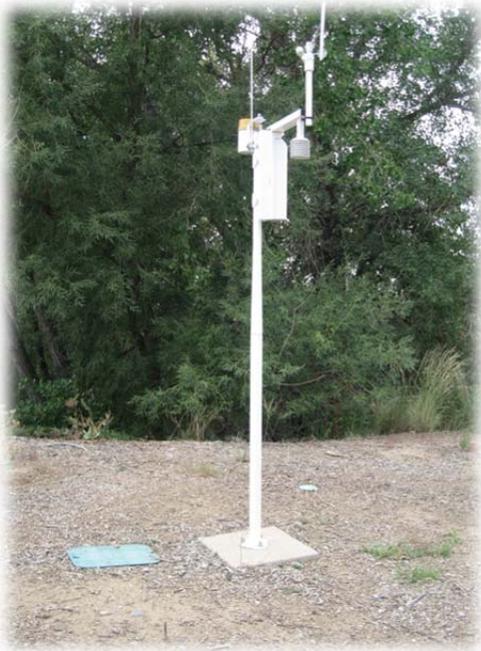
Picture 3 &4. Typical Weather Station & 2" Pipe Repair

Another control system component that is lacking at Hillside is a weather station. A weather station is used to monitor and log environmental conditions (wind, temperature, solar radiation) and determine the daily Evapotranspiration Rate (E.T.) of the turf grass. E.T. is a measurement of the water that is lost through evaporation and plant transpiration. The ET value is used by the superintendent to develop a watering

schedule to replace the water loss since the last irrigation cycle. The central computer database has defined precipitation values for each sprinkler and if the daily ET calculated from the weather station was a 0.18", the superintendent can develop an irrigation cycle that will match the 0.18" loss. The weather station can be configured to allow other City of Sidney sites access to the weather data for irrigation run time adjustments. A weather station can easily pay for itself within one season just by the realized water and energy savings. A budget cost for a weather station is \$11,000-\$15,000 for hardware/software and installation.

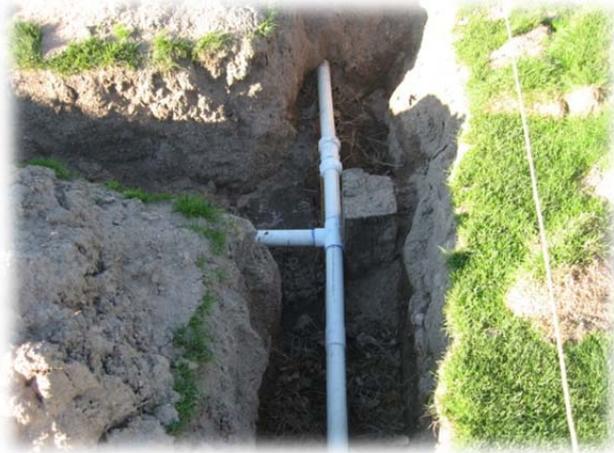
The pipe infrastructure at Hillside is composed predominately of PVC pipe. The club is experiencing an average number of repairs to the pipe infrastructure. The majority of repairs are needed on the 2" lateral network (picture 4).

PVC has been the most commonly used pipe material in golf irrigation applications for many years and has an average service life of 15-20 years. PVC is available in many different classes and schedules depending on the application and pressure requirement. Irrigation systems of similar age typically have Class 200 (CL200) PVC while front end budget conscious courses opted for CL160 PVC. The study was not able to identify the class of PVC pipe that is in the ground at Hillside. There is also some asbestos cement (AC) pipe in the ground at Hillside. AC pipe was a predecessor to PVC. It is considered a hazardous material and

Current golf irrigation technology employs the use of High Density Polyethylene Pipe (HDPE) for the mainline and lateral pipe infrastructure. The advantages of an HDPE system over PVC include; constant working pressure rating, higher cyclic resistance to material failure, freeze resistance, monolithic pipe construction, improved ability to "snake" the pipe through a free form trench alignment, thrust blocking not typically required, high level of impact/scar resistance that is beneficial during vibratory plow installation, and perhaps most important the manufacture of the product is environmentally friendly compared to PVC. The new irrigation system piping infrastructure will benefit for years with the use of HDPE pipe and is highly recommended.

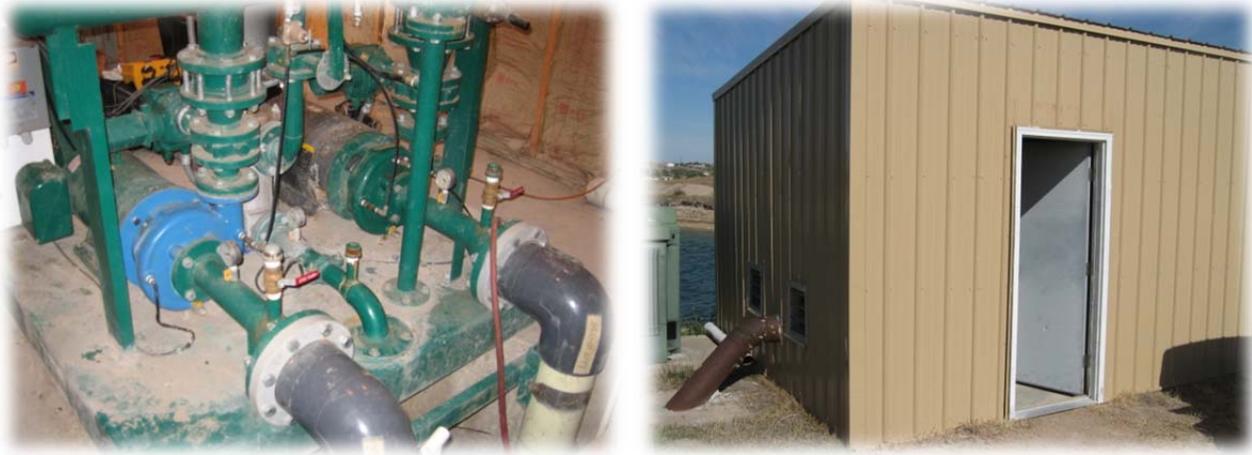
Picture 5 & 6 Main Pump Station Interior and Pump Station Building

The irrigation system has one (1) pumping station located just east of 3 fairway. It is a Watertronics centrifugal lift pump station installed in the spring of 2003. The pumping capacity of the station is 750 gallons per minute (GPM) at a discharge pressure of 125 pounds per square inch (psi). The pump station is fitted with one (1) 7.5hp pressure sustain pump, one (1) 40 hp pump and one (1) 60hp pump. Pump testing on the 40 and 60 hp pumps was completed during the data collection process. The pump testing identified the flow performance for each pump, the amount of energy required to operate the pump and a pump plant efficiency value. The pumping plant efficiency value is calculated by multiplying the motor efficiency (noted on the motor) by the pump efficiency, (determined by flow testing). A typical 40-60 horsepower motor will have an efficiency rating in the low ninety's as is the case with the two motors on the station. The efficiency(chart 1) for pump 1 is 49.4% and rates as a poor performer as defined by the Center for Irrigation Technology (CIT). Pump 2 tested as 43.3% efficient. The centrifugal lift station is an inefficient method to pump water. Centrifugal pumps are typically range in the 60-65% efficient neighborhood whereas a vertical turbine pump is typically 80-85% efficient. There is a great opportunity for Hillside to realize operational savings and improved pump performance with a vertical turbine pump station. The existing wet well is 20' deep and can easily accommodate a two vertical turbine pumps.

The pump station is performing as designed but is not providing the needed pressure for holes near the clubhouse. The static pressure model has identified that hole 9, 10, 18, driving range and putting green area does not have adequate pressure for the sprinkler heads to perform as designed. Two solutions are available, install a booster pump to supply adequate pressure to those areas, or move the pump station to a location that will supply adequate pressure to the holes 9, 10, 18 and the driving range complex.

Pumping System	Motor Efficiency	Pump Efficiency	System Efficiency
Pump #1 (40 HP)	91.7%	53.8%	49.4% = Low Rating
Pump #2 (60 HP)	93.0%	46.6%	43.4% = Low Rating

The pump station is sized to apply 0.22" of water to the 83 acres of irrigated turf in 11 hours. A typical irrigation water window is 8-10 hours. If the current irrigation cycle is impacting course maintenance and play Hillside should consider replacing the pump station with one that has greater capacity. To reduce the water window to 8 hours with a 0.25" application would require a pump station with a 1,200 GPM capacity. An estimated budget for a 1,200GPM pump station is \$110-135K.

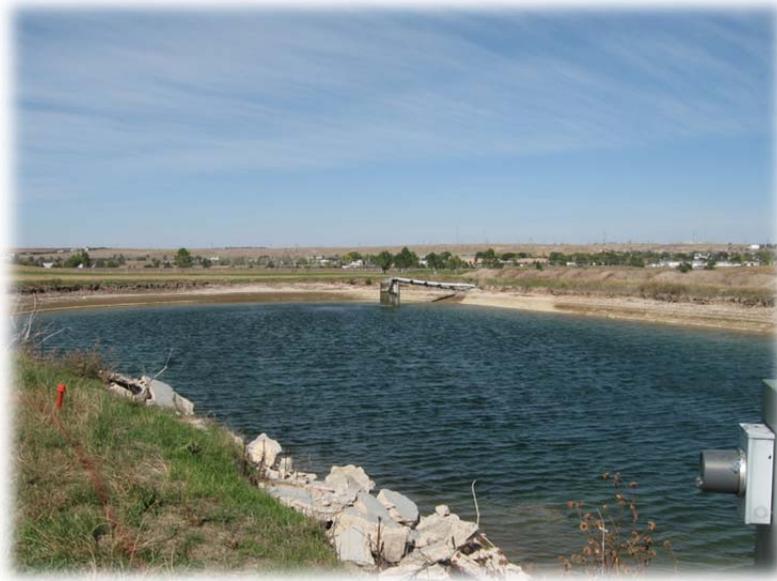
Picture 7. Irrigation Pond After a Heavy Irrigation Cycle (400K Gallons)

The existing pond adjacent to the pump station on hole 3 supplies the water for the irrigation system. The surface area of the pond is 26,014 square feet, about 0.60 surface acres. The pond is relatively small in terms of surface area, but fairly deep at approximately 20'. There is adequate water storage capacity to meet the needs of the golf course, but during heavy irrigation cycles, the drawdown of the pond is significant. This can cause bank erosion as well as be aesthetically distracting. Water is supplied to the pond via off site city well and transferred through an underground pipeline. The transfer line is operated by The City of Sidney.
