Sidney Historic Preservation Handbook

Prepared for the
Historic Preservation Board

Updated and Adopted July 2022

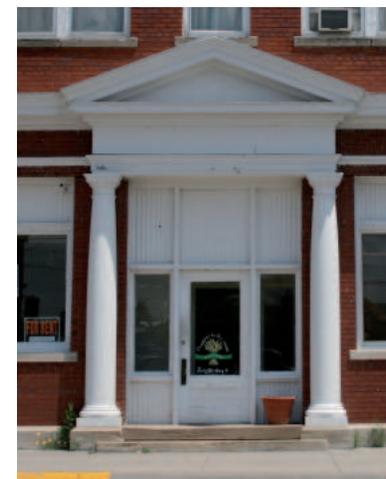
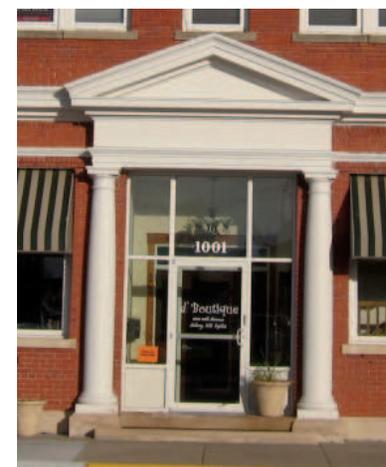
Replacing the original wood entry (top) with an aluminum storefront significantly changed the appearance and character of the entrance. The wood entrance should have been retained and repaired rather than replaced with a different, contemporary material.

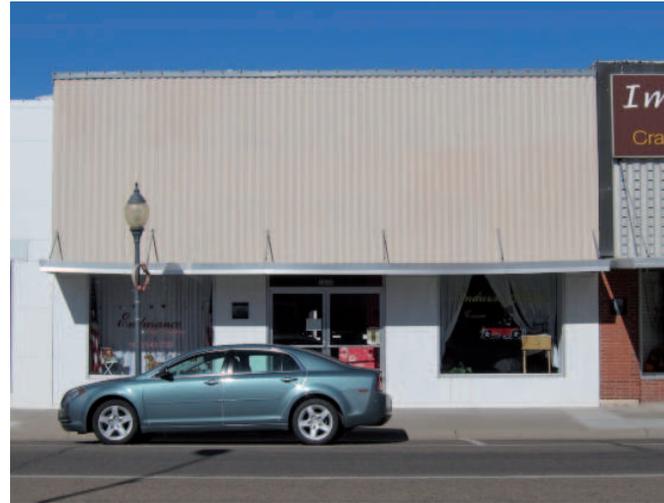
This building at 1034 Illinois Street is classified as noncontributing because the historic facade has been covered with metal and wood.

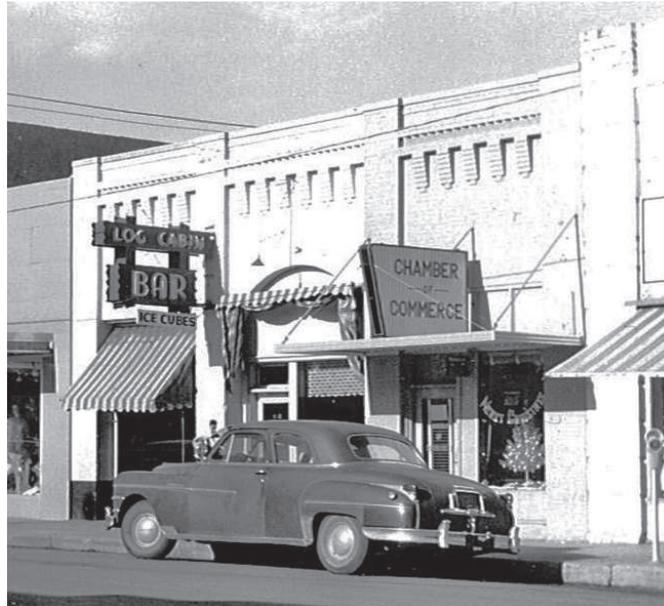
Based on this 1957 photo and inspection of the facade, it is likely that once the wood and metal coverings are removed, the historic facade will be sufficiently intact that the property can be reclassified as contributing.

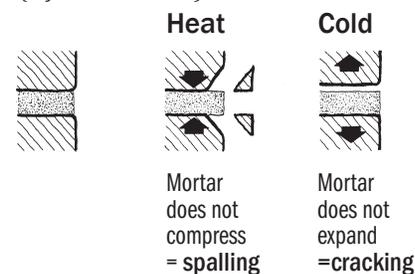
Portland mortar w/ soft brick (inflexible mortar)

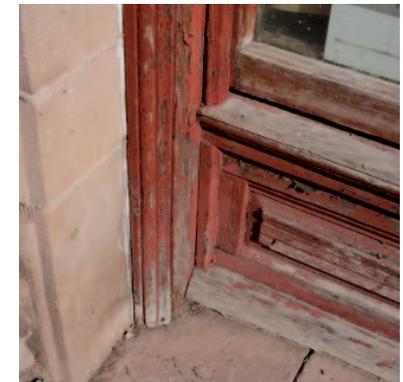
This historic wood should be repaired and only portions too deteriorated to repair should be replaced.

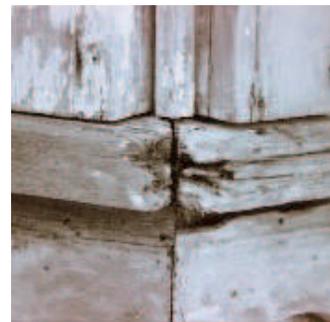
Before restoration

Epoxy Wood Restoration

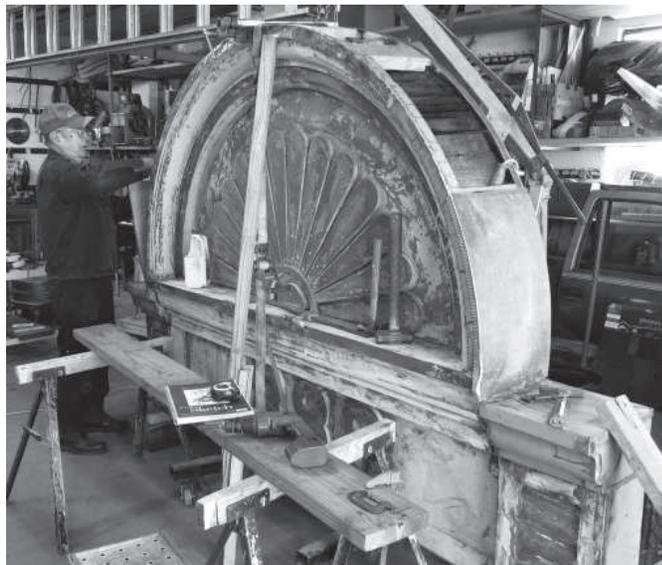
This cornice pediment was removed for restoration. The wood structure was repaired and portions of sheet metal that were dented and rusted were replaced.

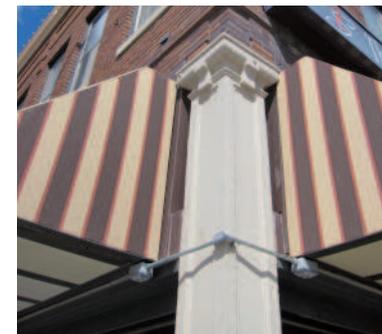
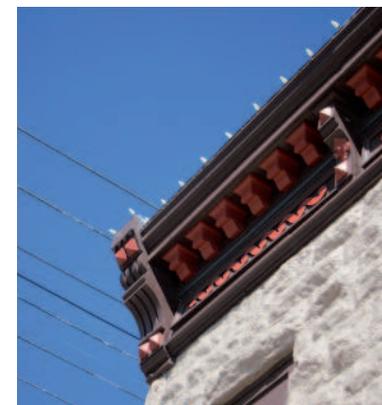
Examples of historic metal features that require appropriate treatment.

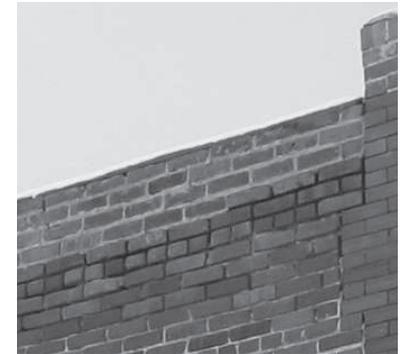
An inadequate membrane and flashing at the parapet has caused the mortar at this exterior wall to erode.

Parapets and copings can become deteriorated over time. If the coping is masonry, eventually water can erode the mortar and penetrate the parapet. Deteriorated parapet mortar is typically a sign the coping has failed.

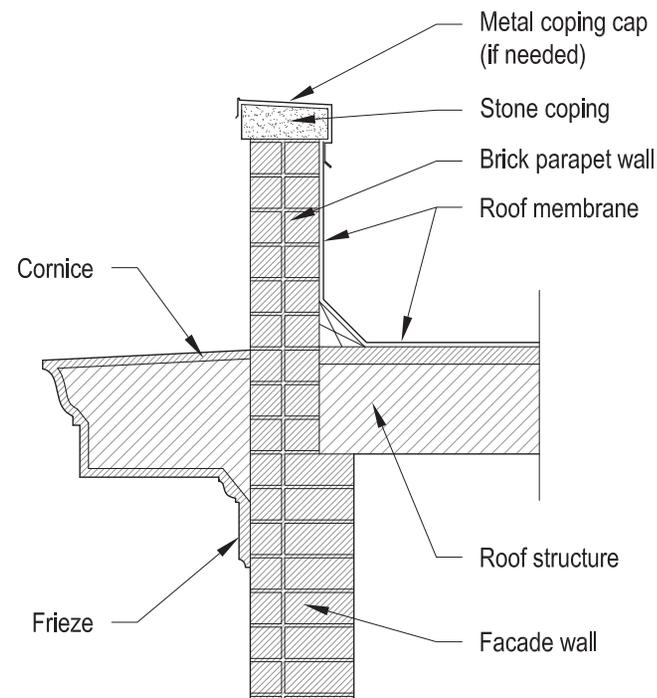
Detail section drawing of a typical parapet and cornice.

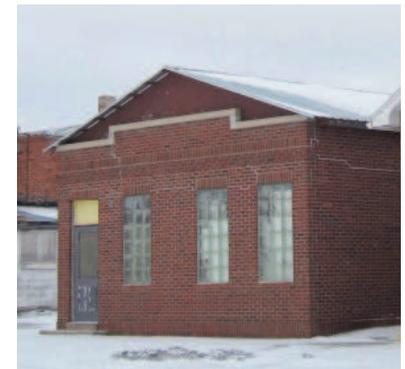
The addition of a gable roof over a flat-roofed historic building significantly changes the character of the building.

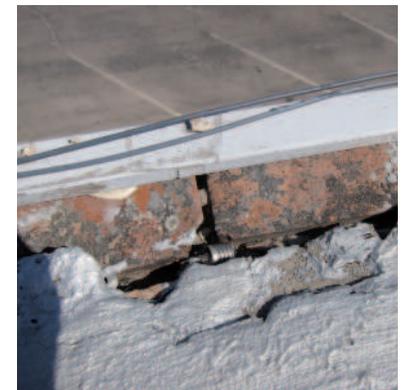
The horizontal surface of this parapet has not had a proper coping for decades leaving the mortar in the corbelled parapet wall to washing out.

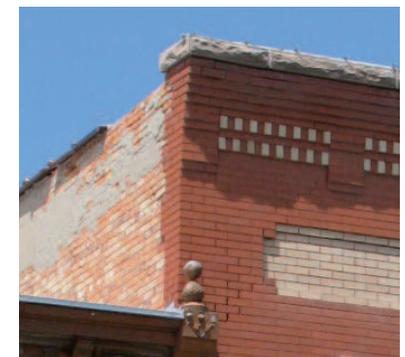
A decorative stone coping is used on the street-facing facade and the side walls are coped with glazed terra cotta; a section of which is missing.

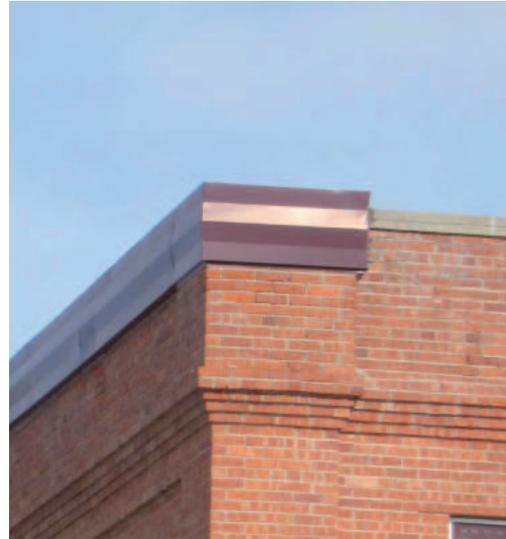
If a coping requires a metal cap, match the color of the metal to the existing coping and do not extend the metal below the coping.

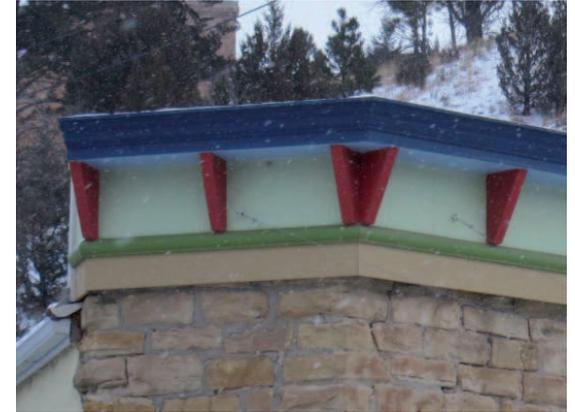
This simple, stylized replacement cornice is a reasonable solution when an ornate metal cornice is missing from a building.

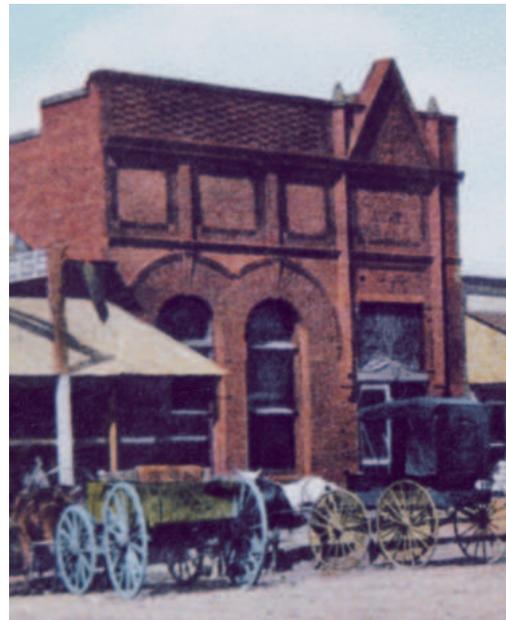
Removal of the historic masonry parapet severely altered the character of this historic bank building.

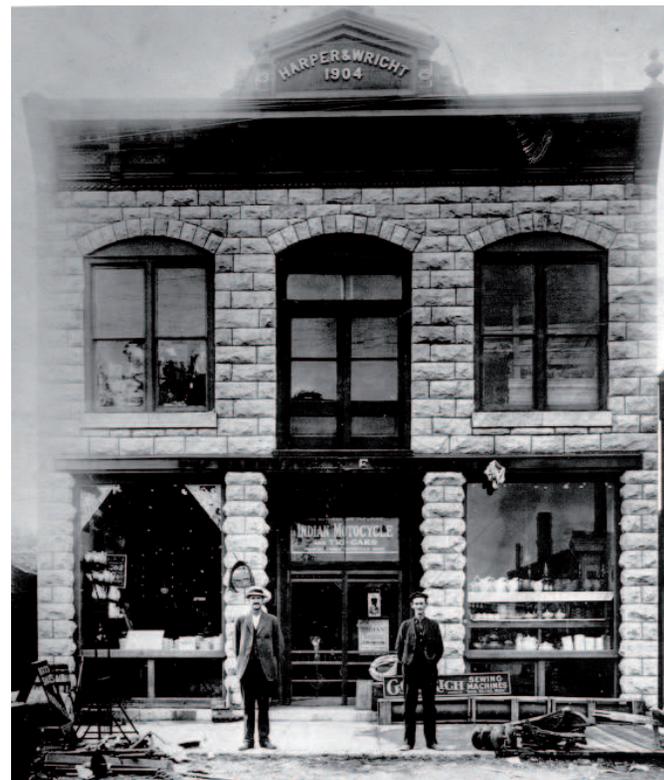
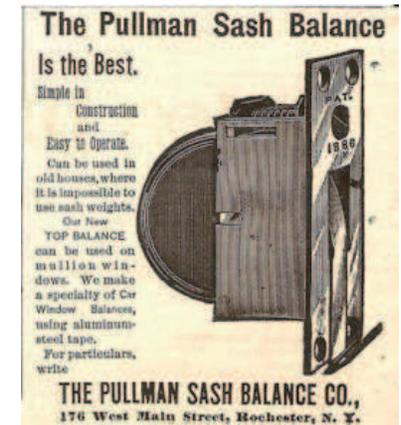
Pullman Balances can replace sash weights and pulleys allowing the sash weight pocket to be filled with insulation.

- Replace weather stripping with new.
- Remove the window weights, replace the sash cords with Pullman springs and fill the weight pockets with insulation.

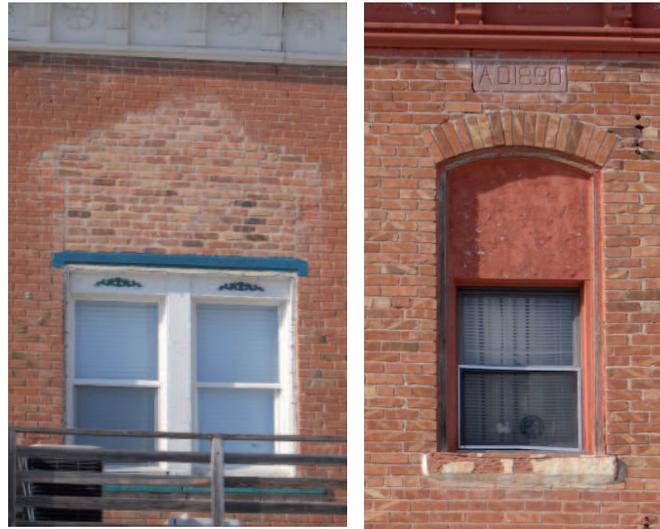
Don't infill a window opening to reduce its size. Window style, size, configuration and type are significant character-defining elements of any historic building.

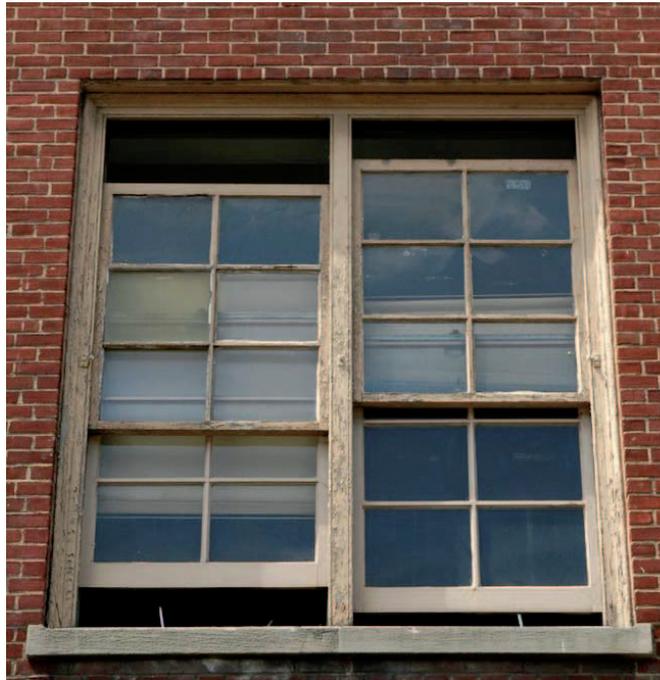
Although the paint is peeling and glazing is hard and cracked, these windows should be rehabilitated and fitted with a storm window rather than replaced.

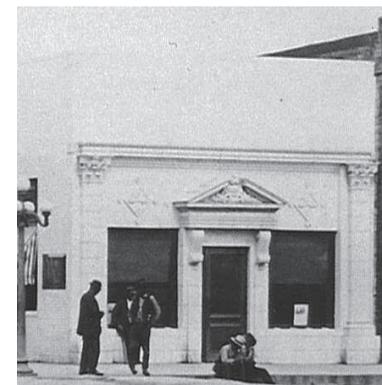
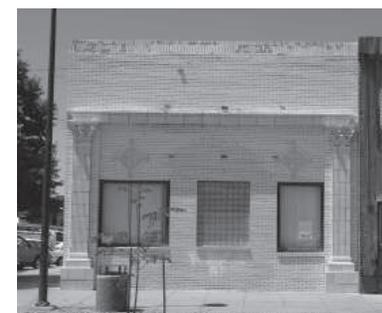
The pediment of the building above was removed which altered the building's character.

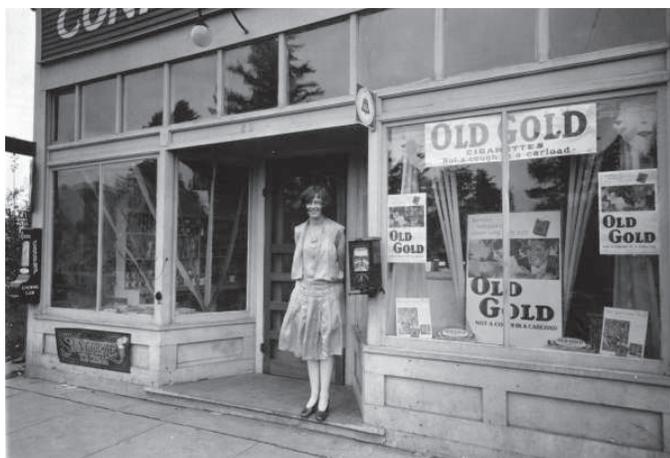
The design and construction of this vernacular storefront would be appropriate for a variety of historic buildings.

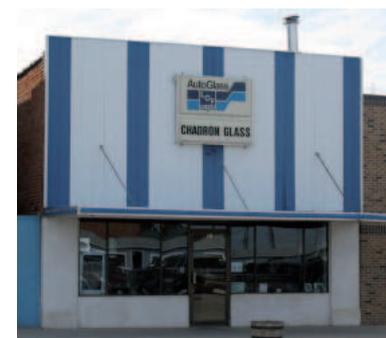
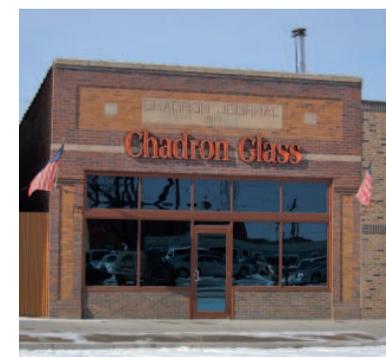
Removal of the metal slip cover and stucco revealed masonry that only required cleaning and limited repair.

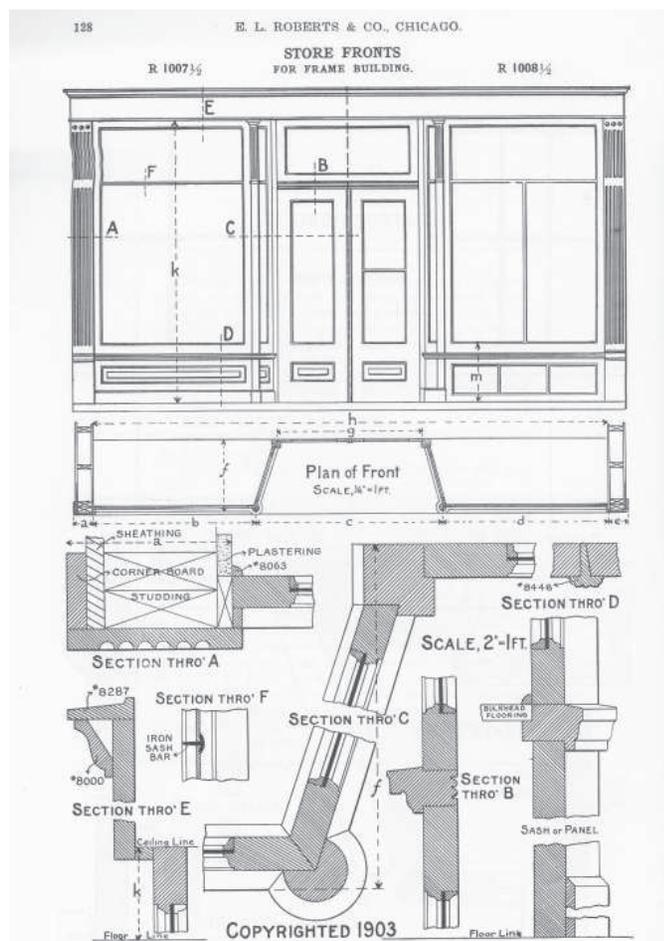
This page from a 1903 millwork catalog shows the construction of a wood, Victorian Era storefront.

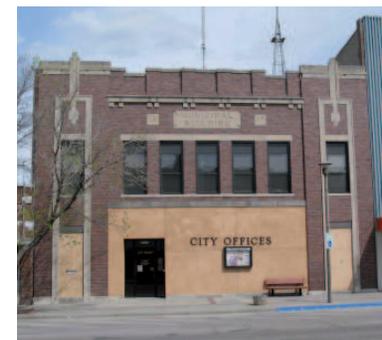
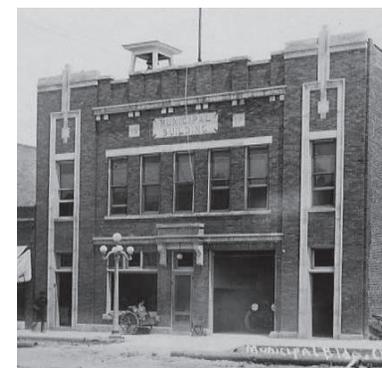
Removal of significant detail and fenestrations greatly altered the street level character of this building.

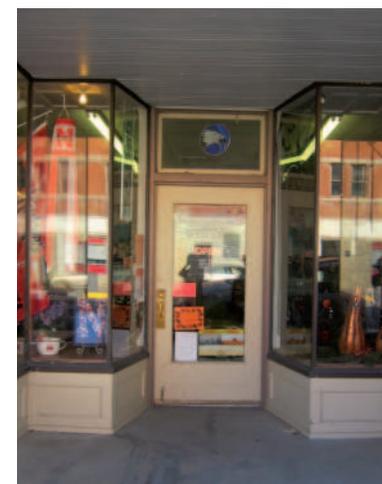
Historic storefronts like this one should be repaired and must not be removed and replaced.

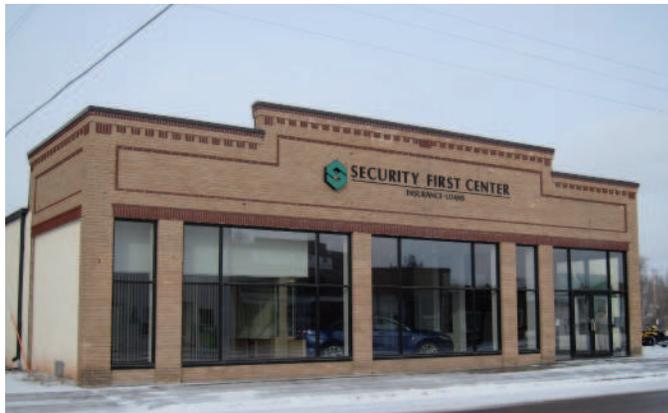
The installation of a dark anodized aluminum replacement storefront works well given the style and scale of the building.

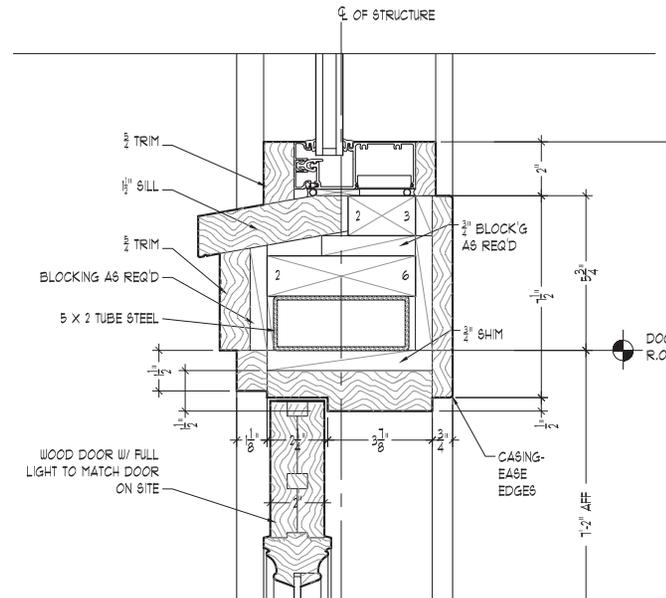
This architectural detail shows the use of a Kawneer storefront frame with insulated glass trimmed with wood to give the appearance of a historic wood framed storefront.

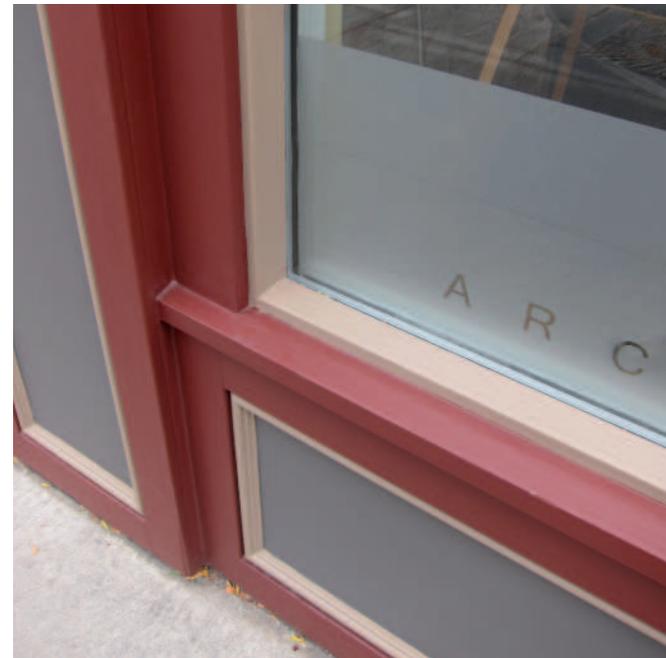
The windows of this storefront reconstruction were double pane insulated glass set directly in the storefront framing with wood stops.

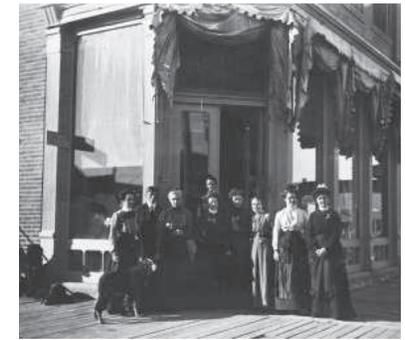
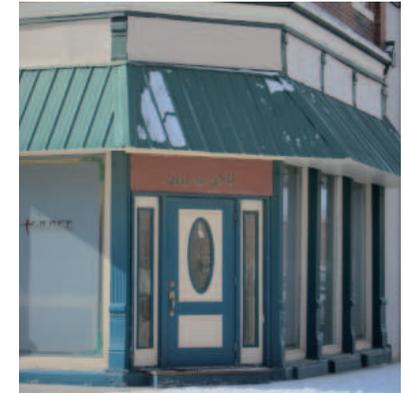
Removal of the bulkhead, the added pent roof and use of a residential door has completely altered the scale and proportions of the Victorian Era storefront above.

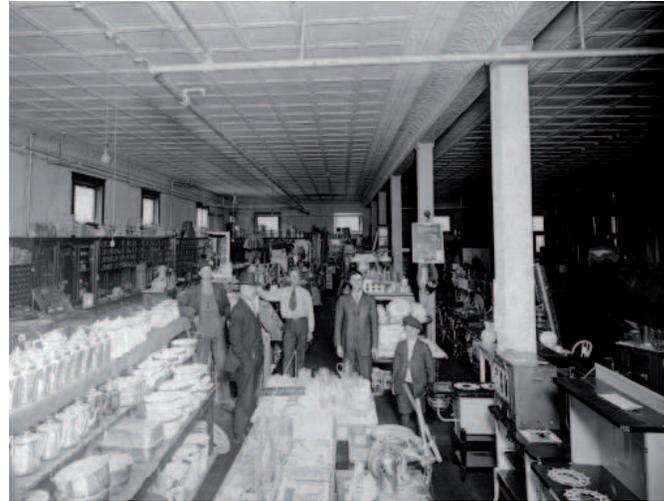
This historic photo of a hardware store shows exposed pipes below the ceiling. Most of the interior illumination is being provided by display and transom windows.

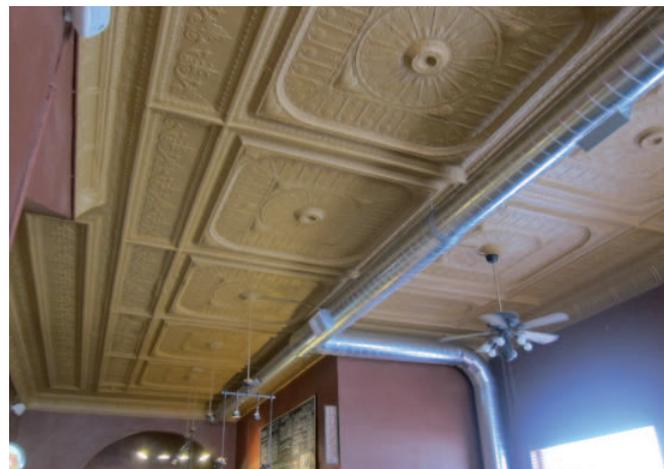
A historic tin ceiling with exposed spiral ductwork.

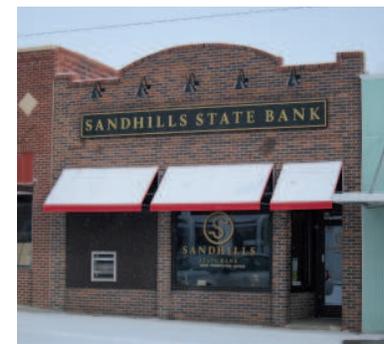
Installing multiple smaller canopies between the masonry piers is historically appropriate and can add interest to a facade.

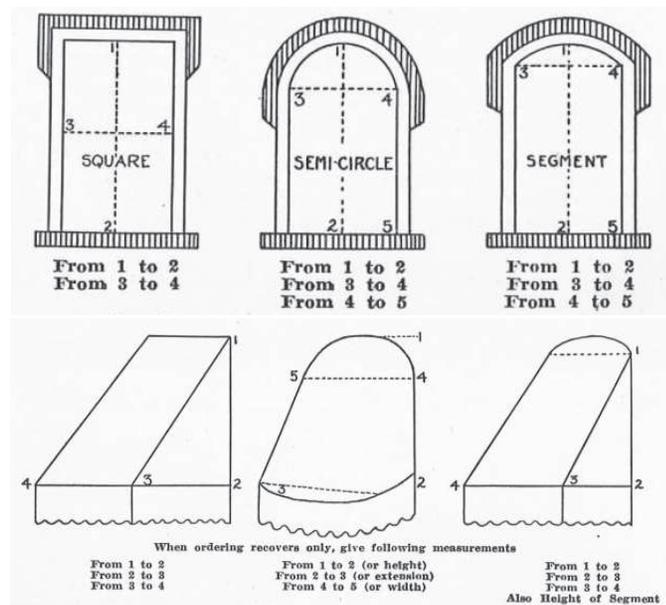
The shape of the awning must correspond to the shape of the window. For example, don't use a curved awning on square window.

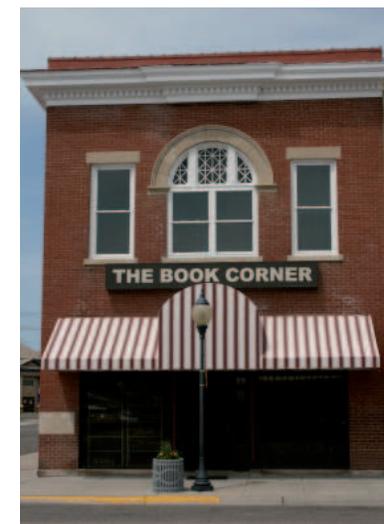
This shape of canopy is not appropriate to the facade. It is also too large and covers architectural details.

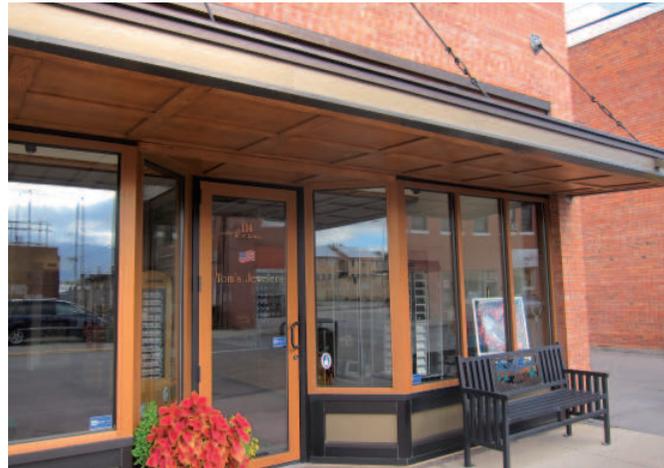
This canopy is an appropriate replacement on an Early 20th-century Commercial storefront.

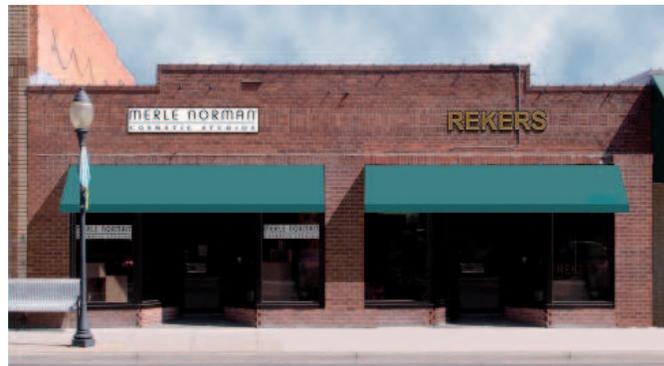
Consultant Scott Day recommended awnings that are open at the bottom and mounted at the head of the storefront windows.

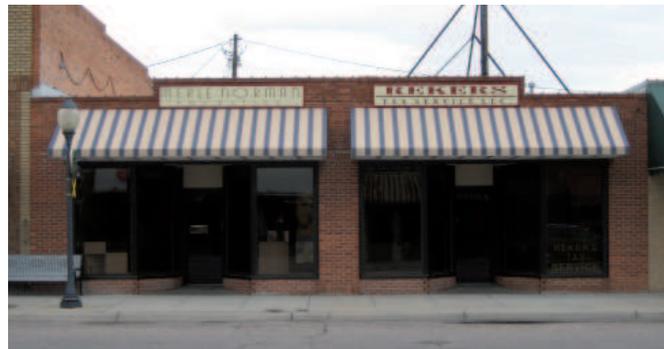
The awnings that were installed were enclosed with plastic grills at the bottom and were mounted significantly higher. The awnings covered significant decorative brickwork, altered the proportions of the facade and did not leave sufficient room for signage.

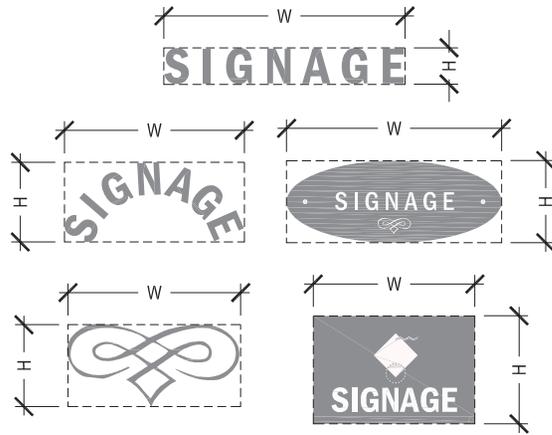
Fig. 6A

6.3e **DO** measure the size of a sign as follows:

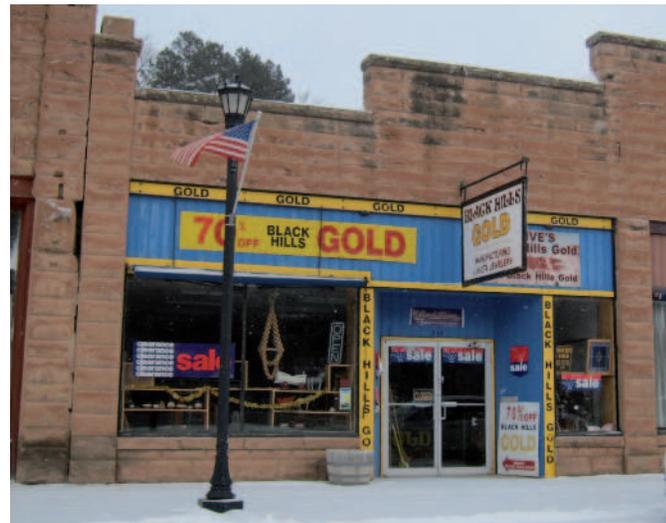
Bright primary colors and too much signage clutter this storefront

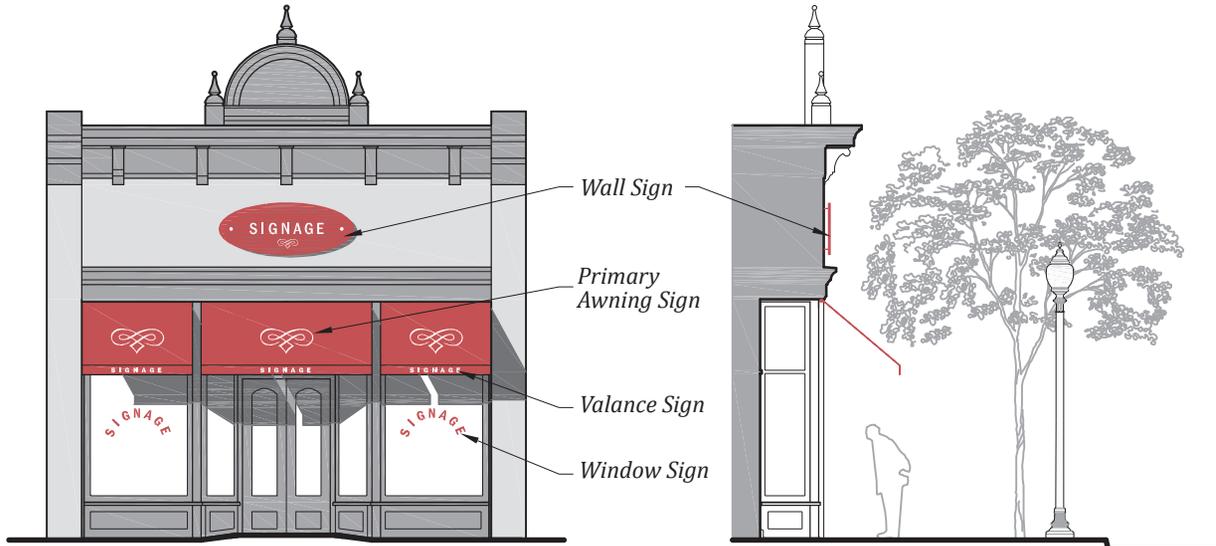
Fig. 6B

Different Sign Types on Victorian Era Facades

6.3i **DO** refer to Figures 6B-6E for the appropriate placement of signs on pre-modern era buildings.

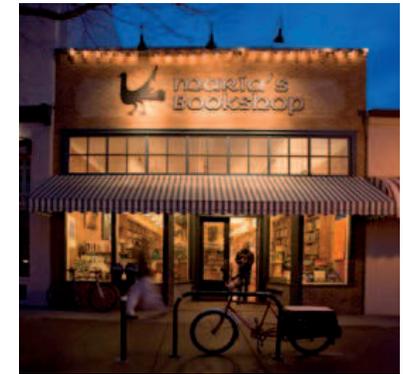
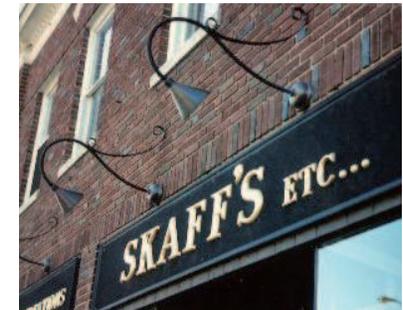
Acceptable Sign Illumination

External Illumination

Within the Sidney Downtown Historic District, new building signage should be illuminated using a light source that is external to signs. This includes various styles of goose-neck lights, barn lights and similar directional lighting.

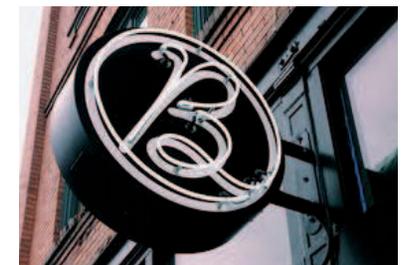
Neon Illumination

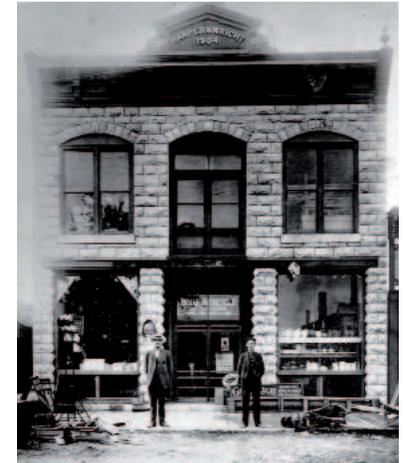
The 1904 Harper & Wright building in Sidney was constructed of limestone like a number of other buildings of this era. The double windows are more unusual for this era.

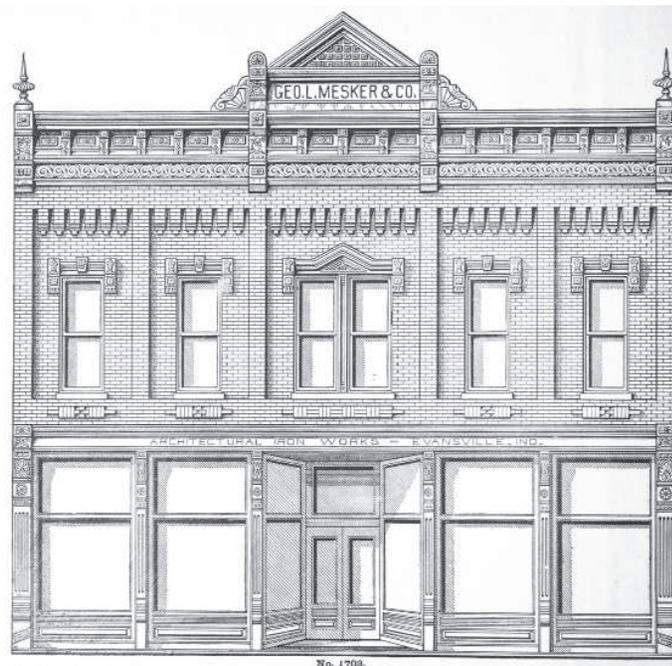
This illustration from the 1899 Mesker Architectural Ironworks catalog shows a typical Victorian Era building that could be found downtown. Throughout the region, cast iron columns can be found with the name of Geo. L. Mesker & Co. cast at the base.

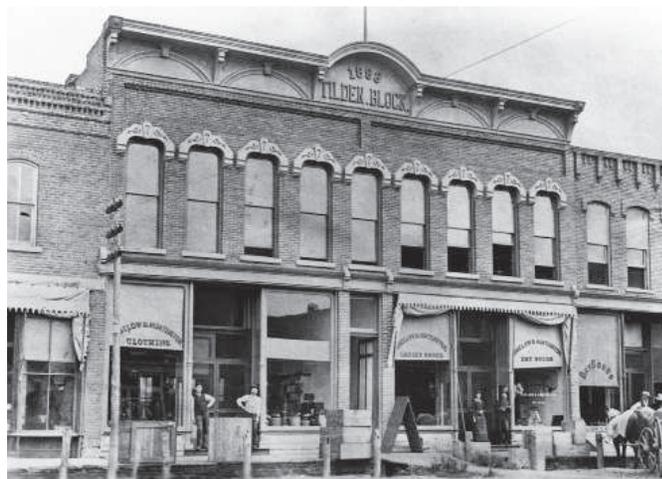
The above photo illustrates many of the characteristics of Victorian Era commercial buildings. A common block arrangement was to have two storefronts with a central stairway to access apartment above.

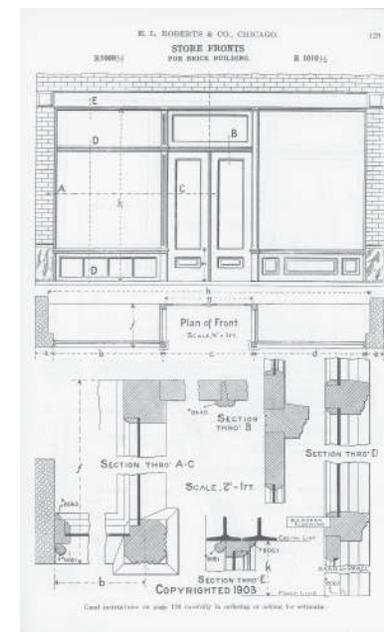
Wooden Victorian Era storefronts were also available by mail order. Historic trade catalogs (available online) can be a valuable source when repairing or reconstructing a storefront.

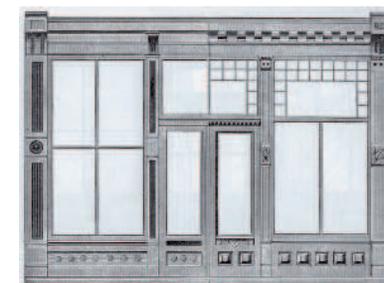
Metal storefront options from Mesker Architectural Ironworks.

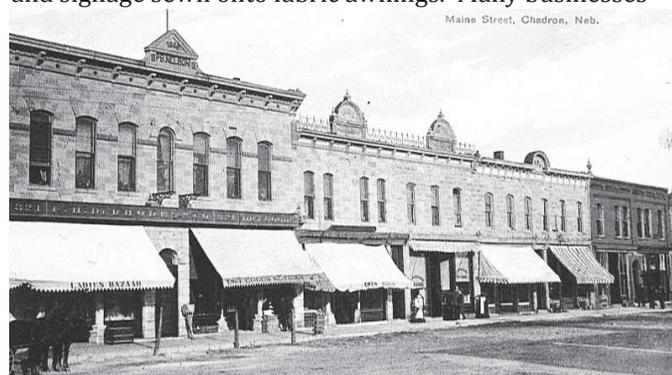
Retractable fabric awnings were a typical feature of Victorian Era storefronts. They were usually attached above the display windows and transom. They often doubled as signage for the store.

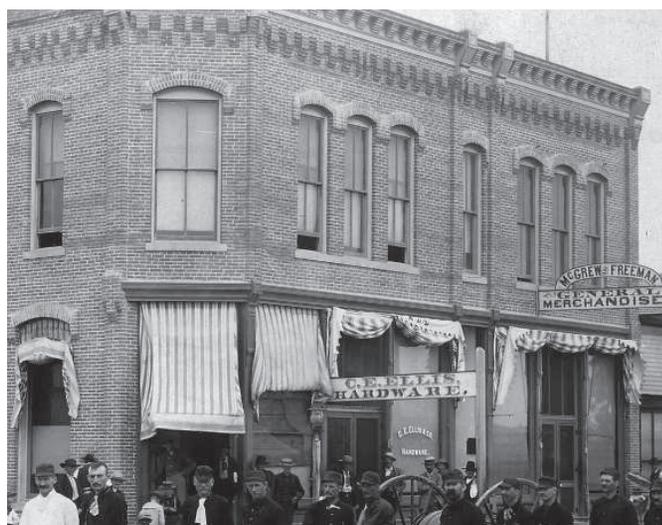
Heavy brick corbels were often constructed below the cornice. Signage was usually located on the window, awning or a sign panel perpendicular to the sidewalk.

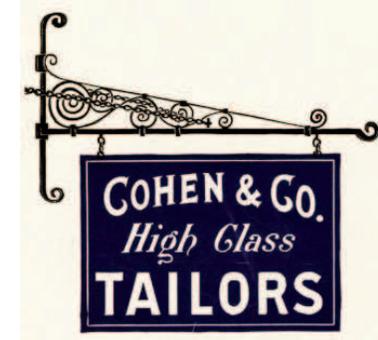
Although most Victorian Era signs in Sidney were likely hand painted on wood, enamel metal signs, like this one from the 1900 Benfield Milne Mfg. Co. catalog, were available via mail order.

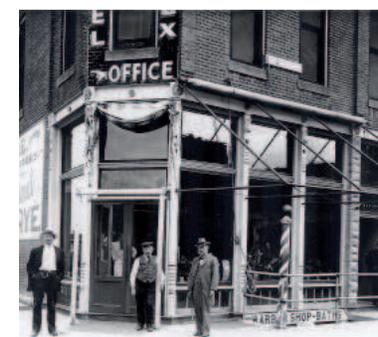
A building located at a street intersection often featured a corner entry. On more elaborate buildings a turret or other feature may be at the building corner.

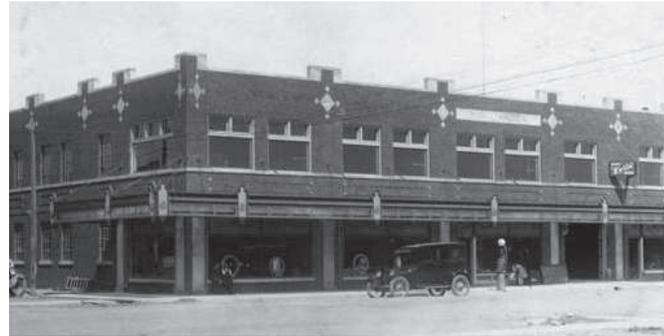
Osborne Garage (1916); The geometric ornament and flat textured brick is common in Early 20th-century Commercial buildings. The upper-story windows and canopy are also character-defining features.

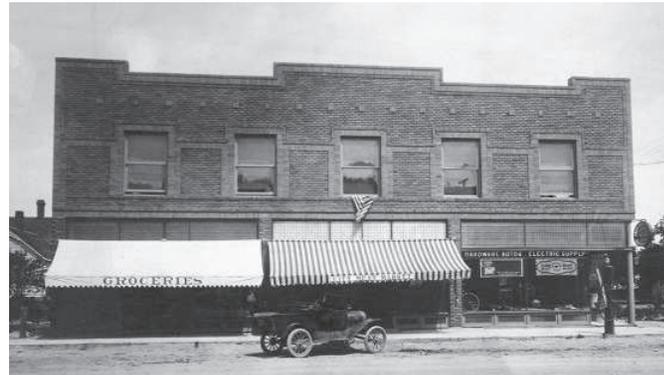
Hardy Building (1916); Like Victorian Era storefronts, Early 20th-century Commercial storefronts incorporated retractable fabric awnings. However, the metal storefront assembly often incorporated the awning mechanism below the prismatic glass transom windows.

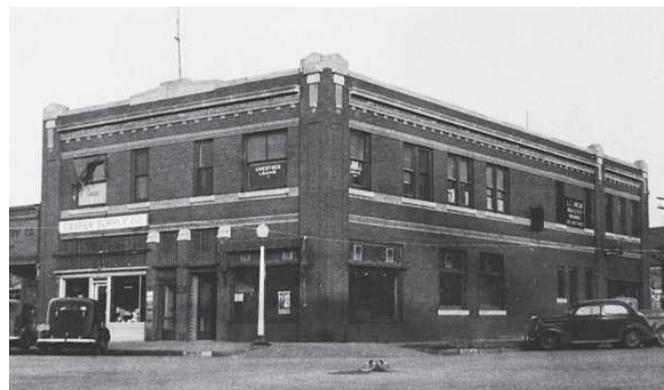
This Early 20th-century Commercial block has influences of both Classical Revival and Prairie School architecture.

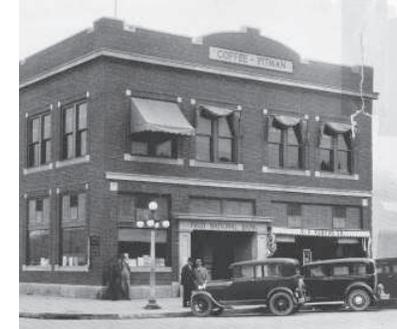
Many Early 20th-century Commercial buildings incorporated some Classic features like the cornice and pediment above.

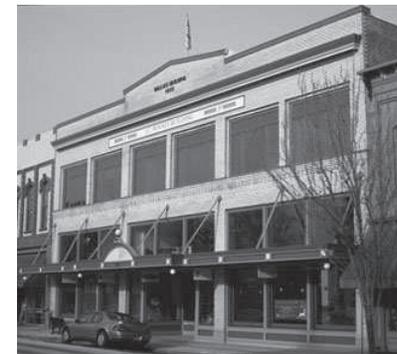
The use of a structural steel frame clad with masonry allowed window openings to be much wide and more horizontal in proportion.

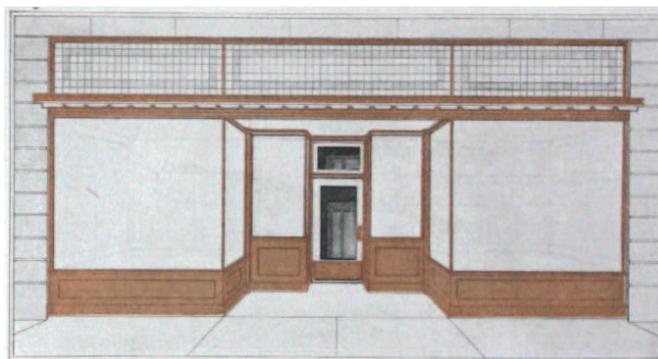
The above Kawneer storefront is very typical of Early 20th-century Commercial storefronts.

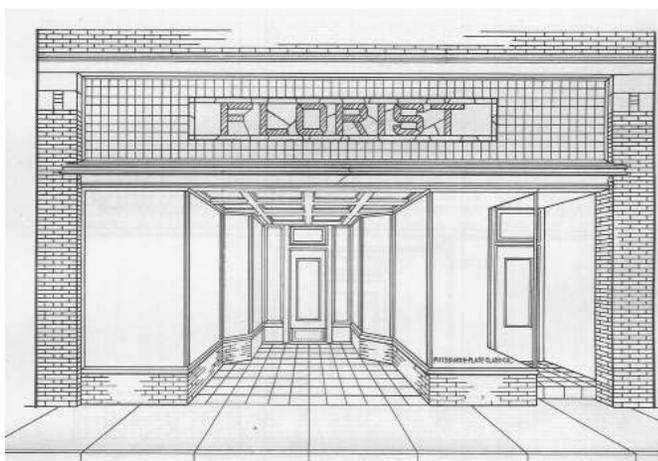
As this image from a 1920 Easysset catalog shows how transoms could incorporate decorative stained glass and display windows could be quite deep.

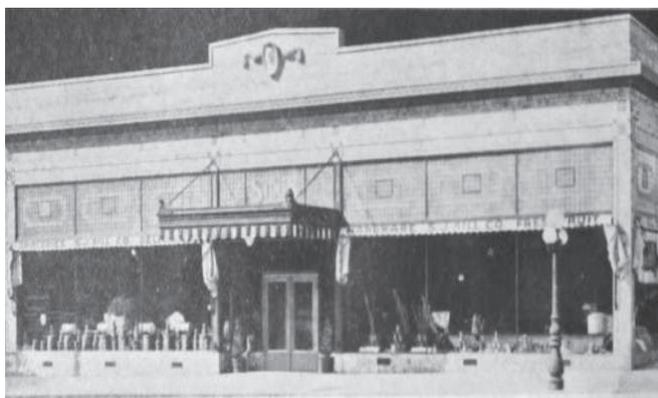
A fixed canopy or marquee were sometimes on storefronts of this era.

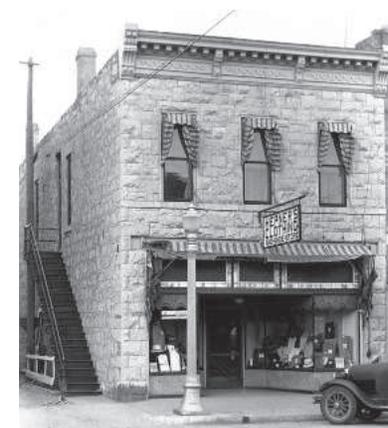
Tyrone Essig Building (1887); This Victorian Era building was updated with a new Early 20th-century Commercial storefront.

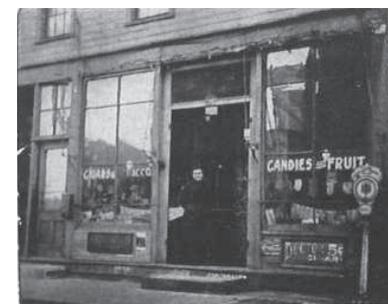
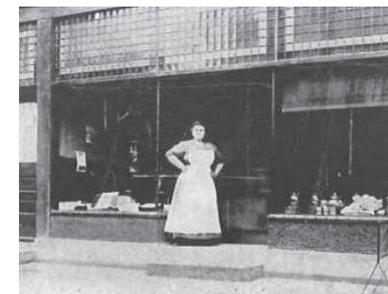
These two photos taken from a 1926 Brasco Storefront Co. illustrates how a Victorian Era wood storefront can be replaced with a new Brasco copper storefront system.

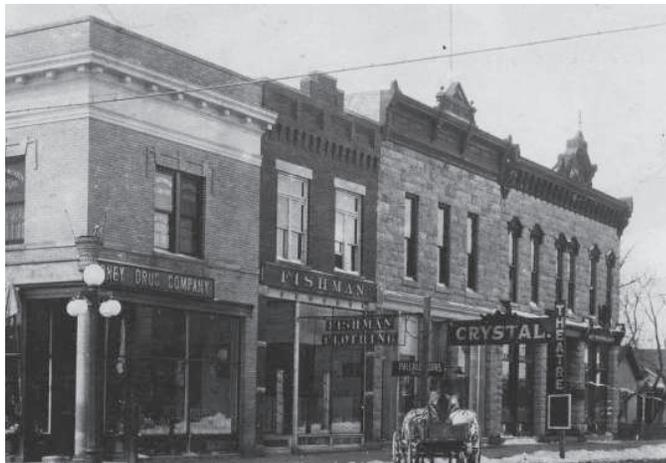
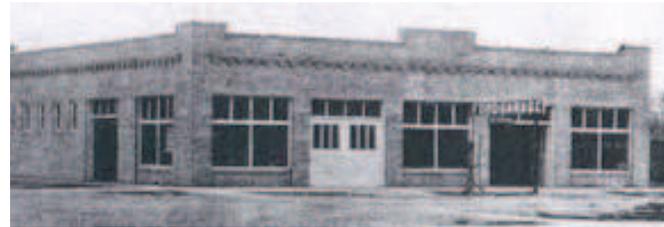
Ford Showroom (ca.1916); This auto showroom has typical garage doors and the style of display windows that was more common for auto uses.

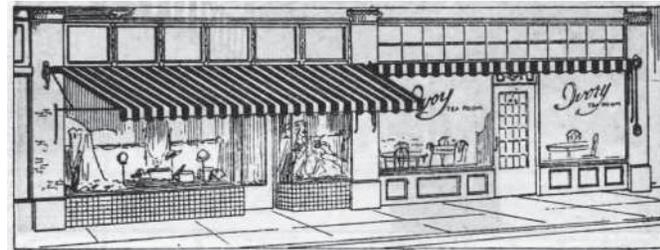
ANCHOR WORM GEAR HOOK AND EYE WINDING HANDLE WITH SLIDE RODS AND CHAIN TO PULL FRAME ARM IN POSITION. ANCHOR COG GEAR WITH SLIDER RODS AND CHAIN TO PULL FRAME ARM IN POSITION.

These awnings were available from the 1920 Anchor Supply Co. catalog.

Awnings: With the development of Early 20th-century Commercial architecture and the prefabricated metal storefront, fabric awnings were typically mounted at the horizontal muntin bar below the transom windows. This allowed for daylighting through the prismatic glass transoms. The prismatic glass prevented glare so it was not necessary to shade the transom. During this time period, fixed canopies became more popular. Although iron and steel canopies were available, in small towns they were usually constructed of a wood frame covered with metal and attached with chains or tie rods. The metal was often bent into the shape of a crown molding, pressed with a decorative pattern or otherwise ornamented.

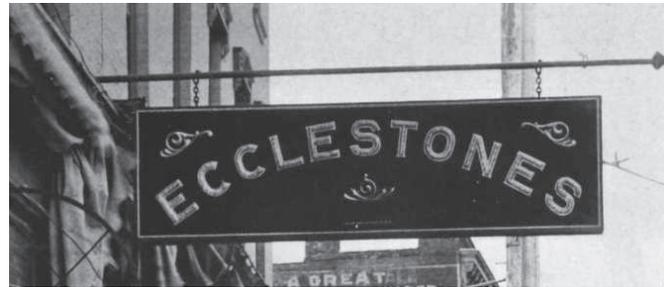
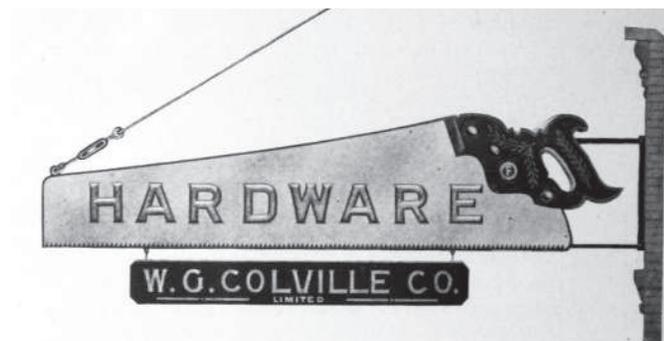
The above two signs were are examples from the 1911 Flexlume catalog.

Signage: Signage became more sophisticated and creative. Dimensional wood and metal letters could be purchased via mail order and applied to sign panels. Sign panels were designed in the shape of objects. Electrification also provided the opportunity for more creative and eye-catching signs. Sheet metal formed into three dimensional channel letters was illuminated with light bulbs set within the letter shape. Metal sign boxes were created in both conventional and unique shapes and illuminated with light bulbs. Internal rotors allowed the bulbs to flash in sequence. During this era, signage became a statement rather than

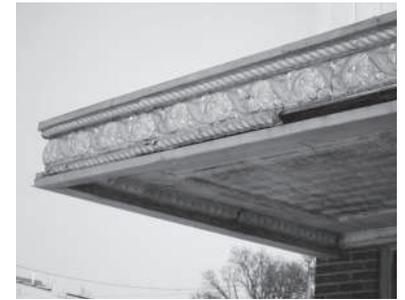
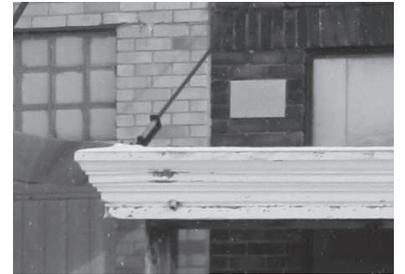
The above two photos show original fixed canopies of Early 20th-century Commercial buildings. Many of these type of canopies were later replaced with aluminum canopies.

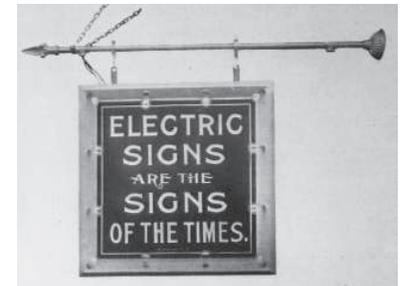
The 1906 Metropolitan Engineering Co. catalog featured the two signs above.

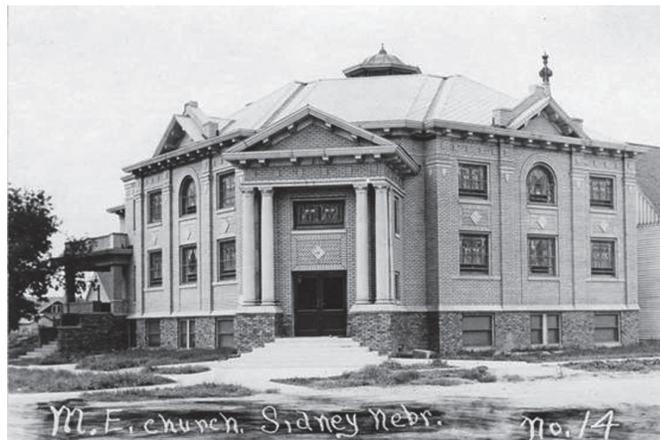
Methodist Episcopal Church (1919); This church has a Classical Revival form and features, but has also incorporates stylized elements of Early 20th-century Commercial design.

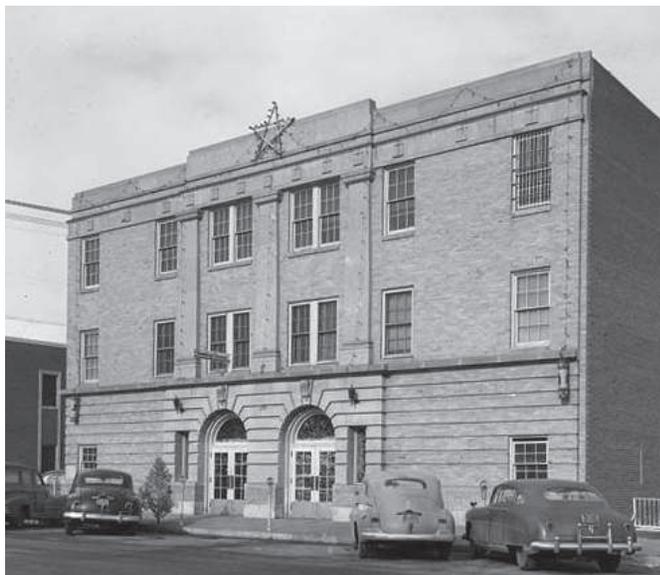
Sidney Municipal Auditorium (1930); flattening of features is an influence by Deco Moderne style.

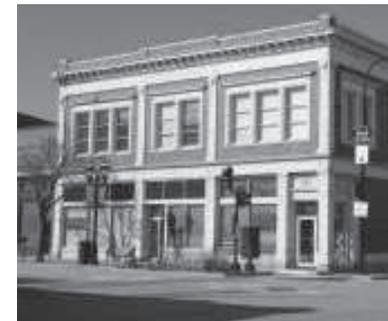
Classical Revival buildings that were designed for retail use have storefront similar to Early 20th Century Commercial style buildings.

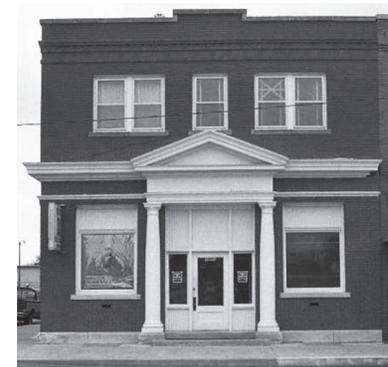
Nebraska State Bank of Sidney (1916-17) has Doric columns and a pediment that is distinctive of Classical Revival architecture. However, it was also influenced by the Early 20th-century Commercial architecture.

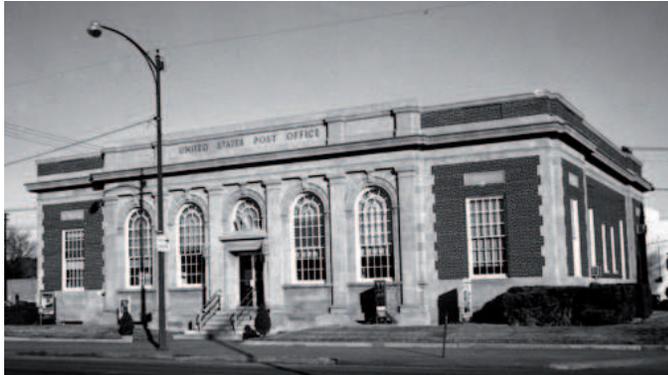
Sidney Post Office (19??); Circular head windows with divided lights, stone pilasters, cornice and quoins are all distinct Classical Revival characteristics.
