Sidney Historic Preservation Handbook

Prepared for the
Historic Preservation Board

Updated and Adopted July 2022

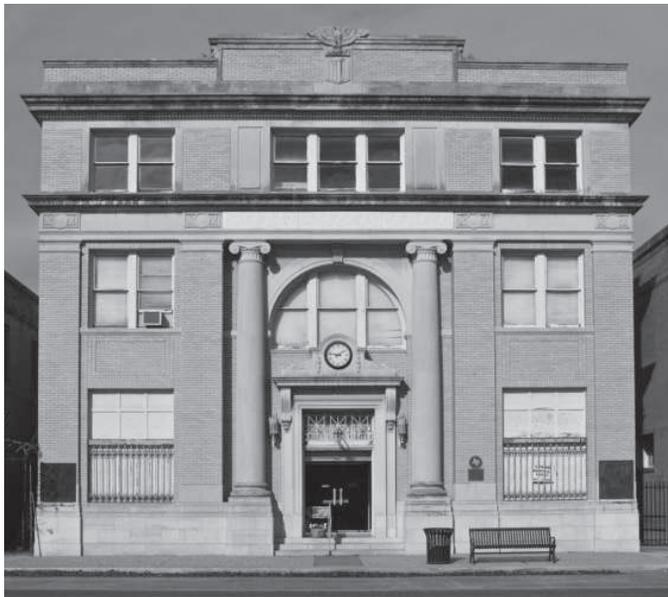
A monumental raised entrance flanked by columns is a common arrangement in Classical Revival architecture.

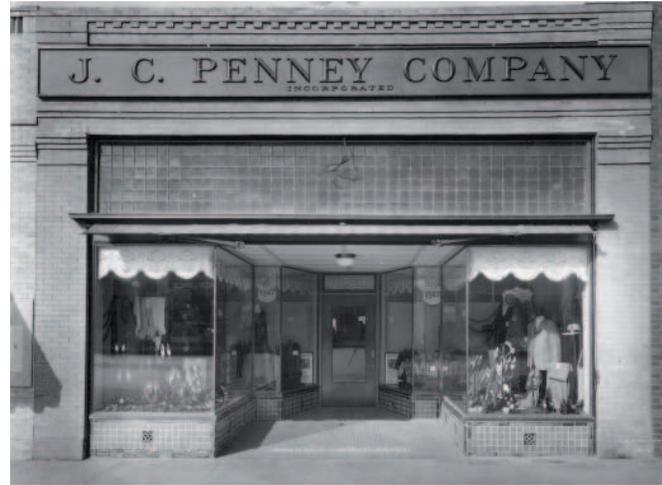
Typical storefronts of this era were deep to provide for more display space. Above the display windows a hood protected the awning when retracted. Bulk heads were covered with a variety of materials including tile, stucco, metal and glass.

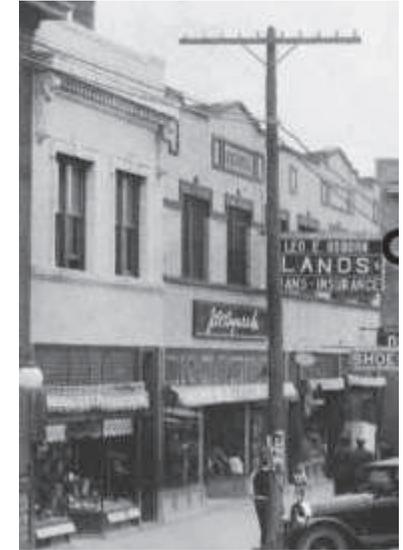
Both the Classical Revival and Early 20th-century Commercial buildings have the same type of storefront.

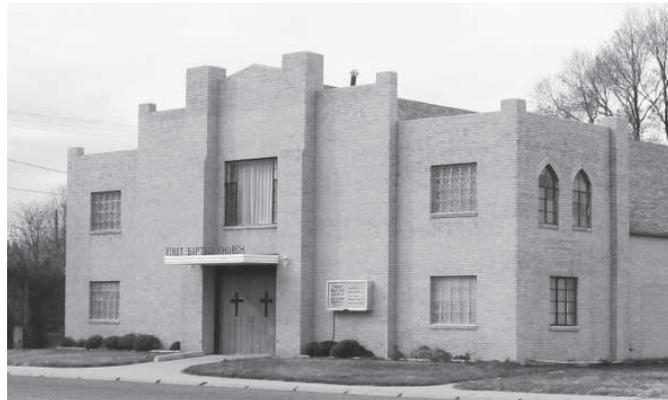
First Baptist Church (ca. 1940): The vertical lines, stepped forms and absence of ornament are influences of both the Art Deco and Art Moderne styles. The glass block, light colored brick, metal canopy and were are also characteristic to design of this era.

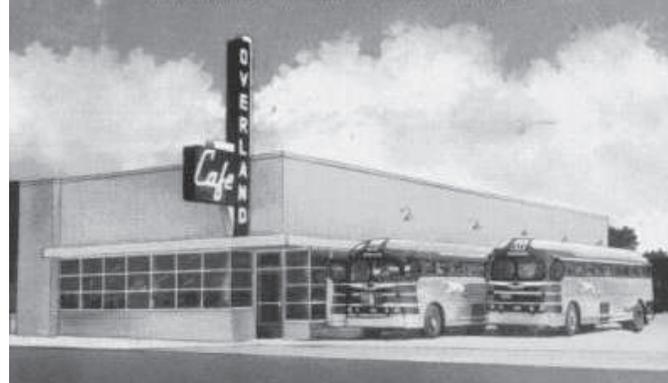
Overland Cafe & Bus Stop (1947); Buff brick, the aluminum canopy and window frames, and corner windows are defining characteristic of this building. Also, significant to the asymmetrical composition is the Overland Cafe sign that provides a vertical counterpoint.

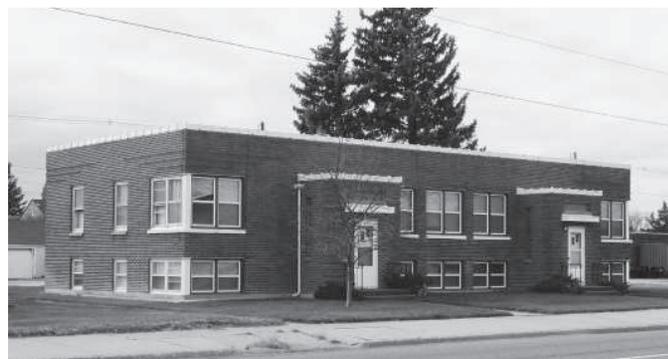
Apartment Building (ca. 1925): This simple red brick apartment building uses corner windows and brickwork that are influences of Art Moderne.

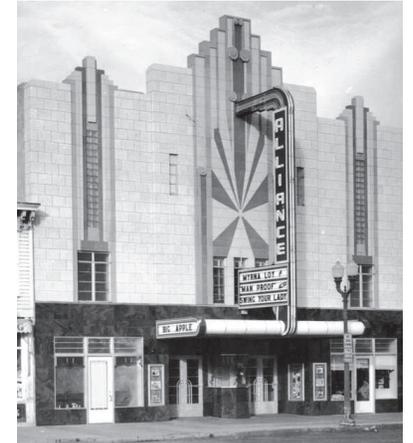
Art Deco architecture often had a very articulated silhouette with no cornice or distinctive coping.

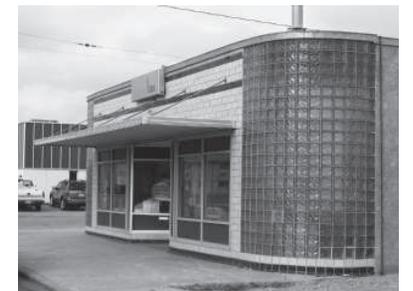
Utility Building (ca. 1955) This building is very typical of simple Art Moderne architecture.

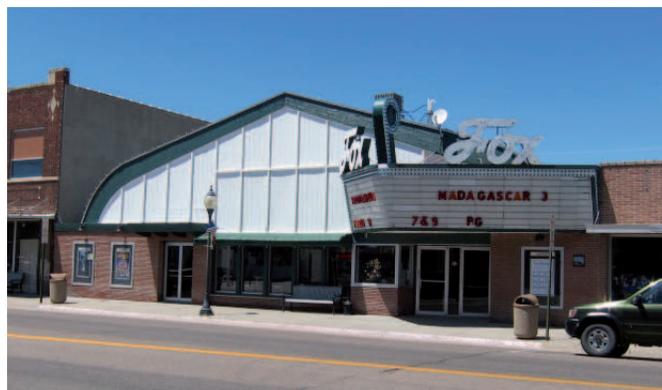
Fox Theater (1949): The stone work, roof form and angular marquee are character defining features of the Mid-century Modern Fox Theater.

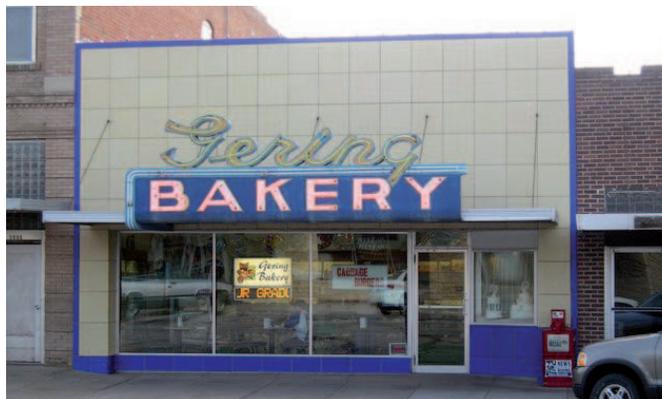
The large neon sign mounted on the aluminum canopy are the most architecturally significant features of this Art Moderne facade.

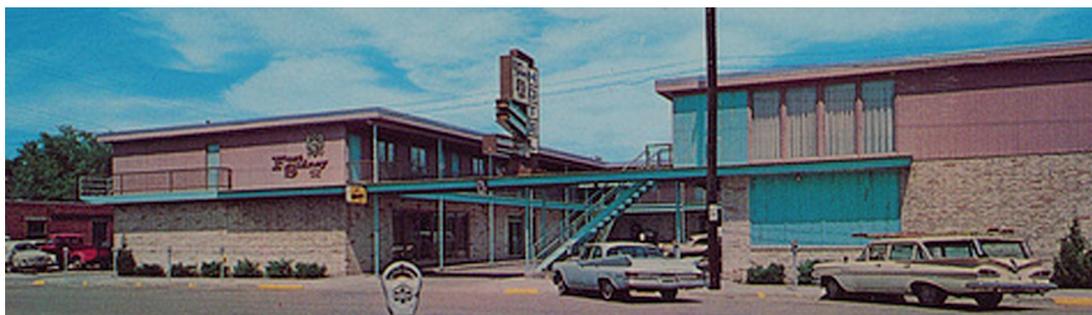
Fort Sidney Motel (1962): This Mid-century Modern building with its horizontal lines and exterior room entrances is typical of motels during this era.

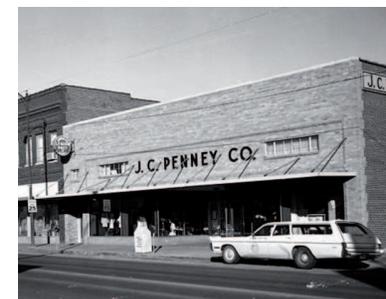
JC Penney Co. (ca 1952): The aluminum canopy is a significant feature of this building.

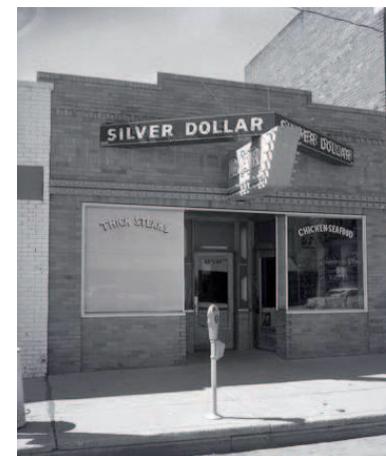
Silver Dollar (ca 1949): The nickel silver storefront and angular flashing sign are distinctive of the Modern Era.

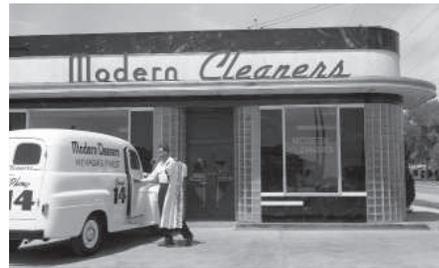
This Art Moderne building has many of the typical features and materials of this style of architecture.

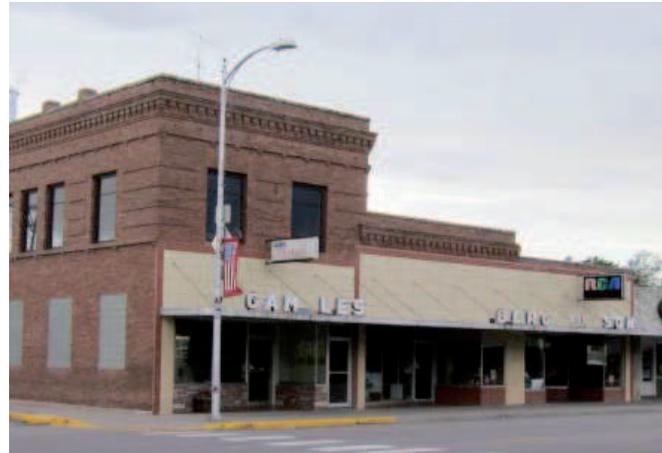
These Early 20th-century Commercial buildings were significantly altered when the Mid-century Modern storefront was installed. The storefront is historically significant.

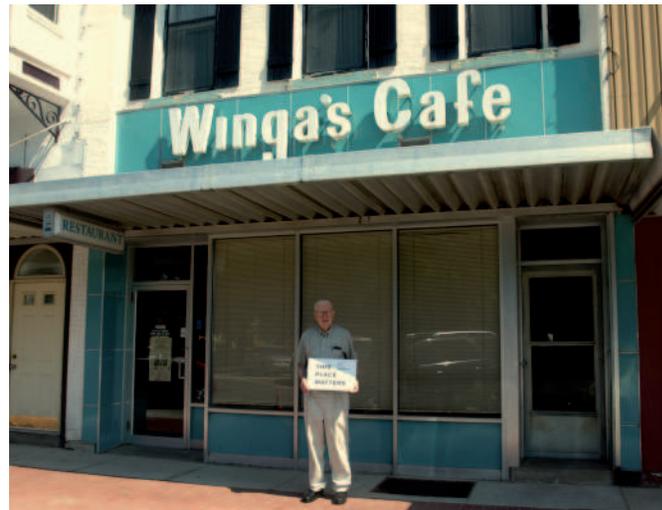
A Mid-century Modern storefront which is completely intact and would be considered historically significant.

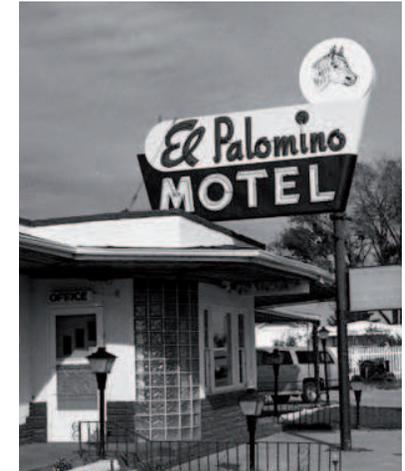
Modern Era neon signs should be retained and repaired rather than replaced.

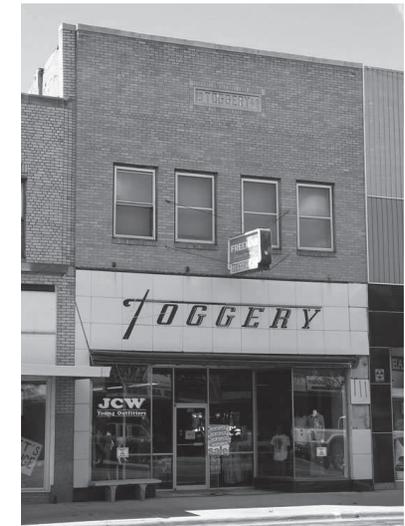
A Modern Era storefront that requires only minor repair.
